## SAN MATEO COUNTY HILLCREST JUVENILE DETENTION CENTER DECONSTRUCTION & REUSE OF SURPLUS ASSETS

### Summary

Deconstruction of doors, roof-mounted solar panels, and other built-ins, and reuse of surplus furniture scattered through a 75,000 square foot single story structure.

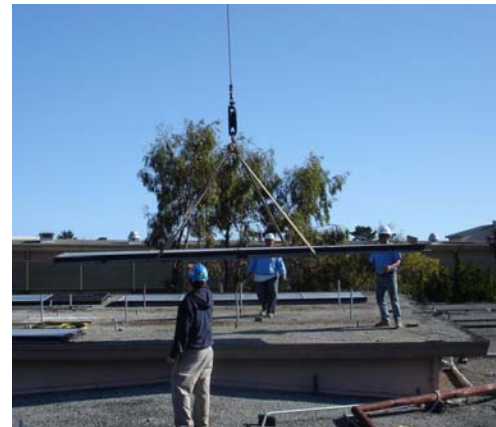
**Dismounting and flying out one of seven roof-installed solar panels.**

The most difficult items were seven roof-mounted hot water solar panels and a built-in freezer. After evaluating alternatives, IRN and its deconstruction crew brought in a crane to facilitate dismantling and removal of the solar panels, each 4' x 16' and weighing approximately 400 pounds. The crane took the weight of the panels as they were disconnected from plumbing and anchorage connections, and flew them to a staging area to be loaded into a shipping container.
